SUMMARY REPORT

EPA Internal Review of the August 5, 2015 Gold King Mine Blowout 8/24/2015

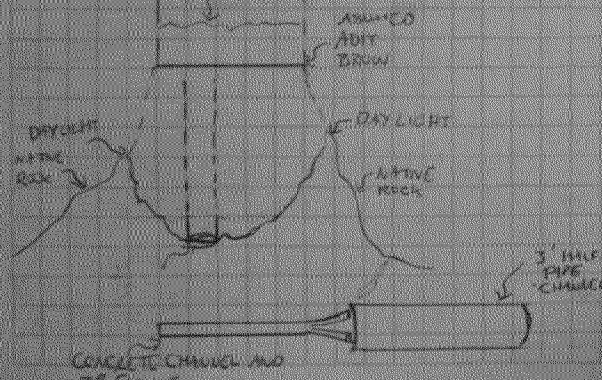
Gold King Mine
2015
EPA Working Assumptions

SIDE VIEW UTS

The excavation in 2014 revealed that two (2) 24-inch pipes were in the tunnel blockage adjacent to the top (roof) of the maximum 10 foot tall Adit. (See Diagram in Attachment D). The presence of water below the two (2) 24-inch pipes indicated the current flow of water was coming out at least four (4) feet below the roof of the Adit, indicating approximately six (6) feet of impounded water above the estimated Adit floor elevation.

5. The DRMS experts supported the removal investigation at the Adit and were present at the site during the operations on August 4 and 5.
 6. The “seep” level coming from the Adit during excavation seemed to be at the mid-level of the material blocking the Adit, indicating a partially filled adit as opposed to a pressurized one (See Attachment D, bottom of two metal pipes).

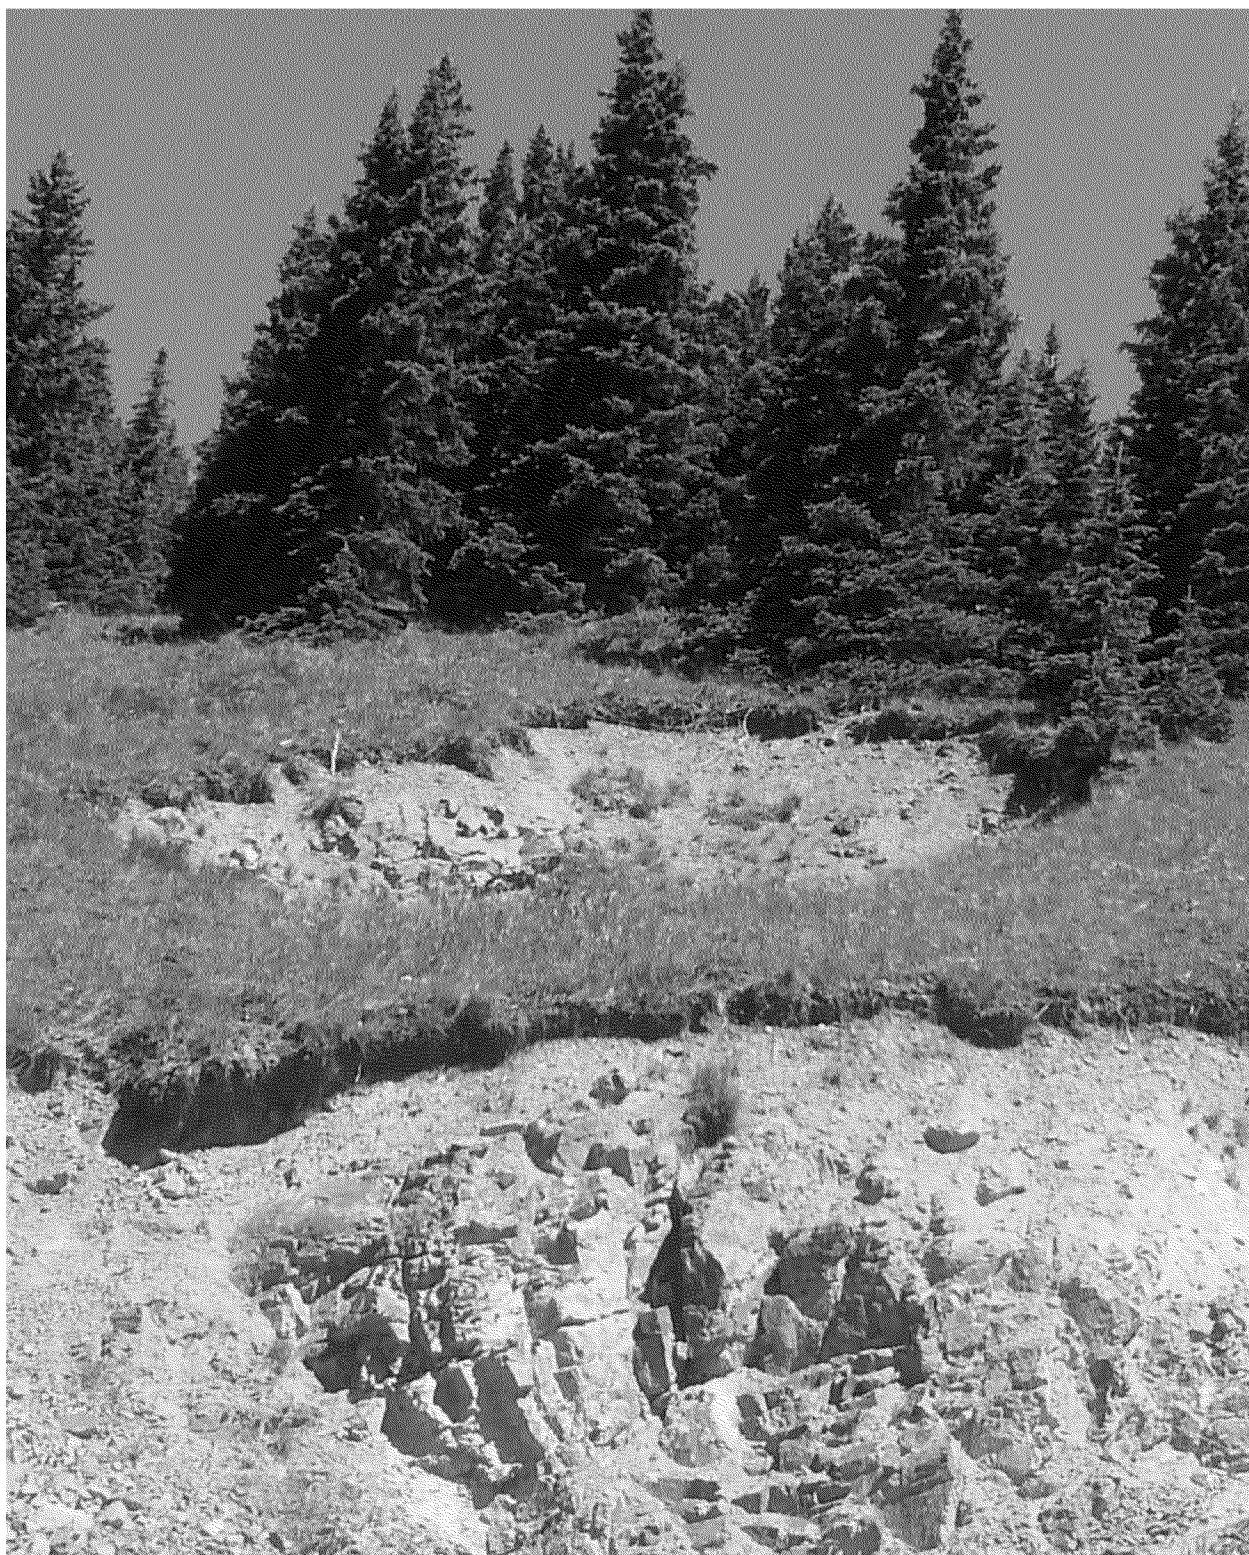
Photo 3 August 18, 2015 – Sink Hole and Slope above Gold King Mine Old Adit

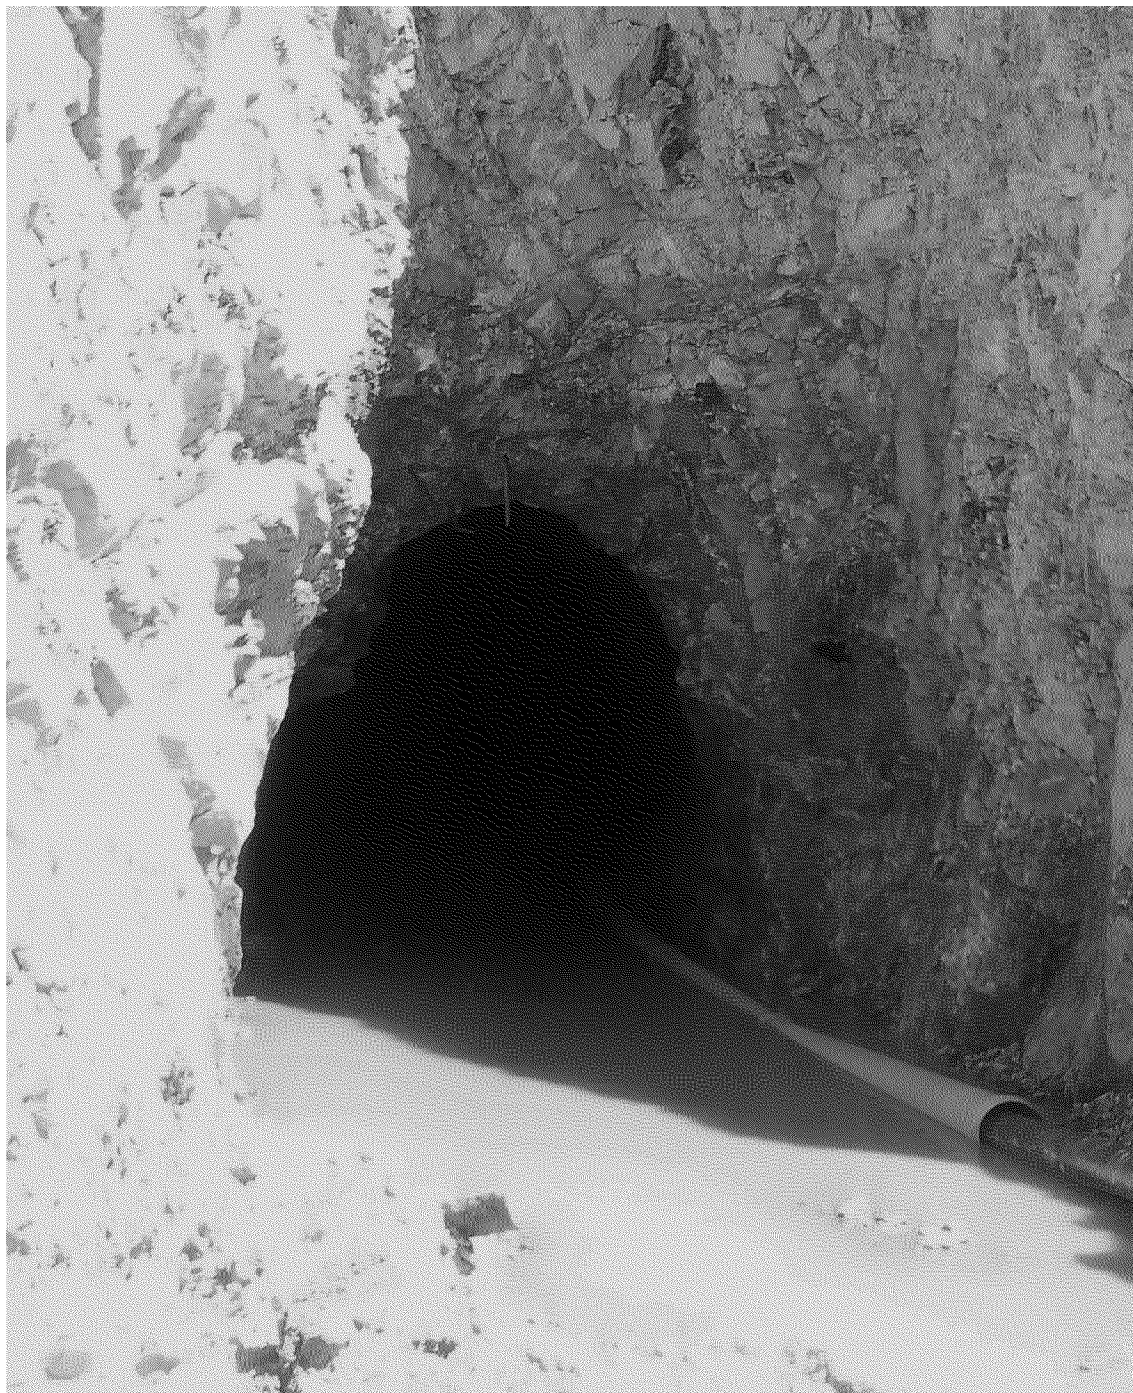
Photo 4 August 18, 2015 – Gold King Mine Level 7 Adit post-blowout
